Manhole Inspection Summary

Manhole # S21K1_006MH

Inspection ☐ Is Incomplete Rating: **3) Fair**

Location Address: **3009 hollins ferry rd**

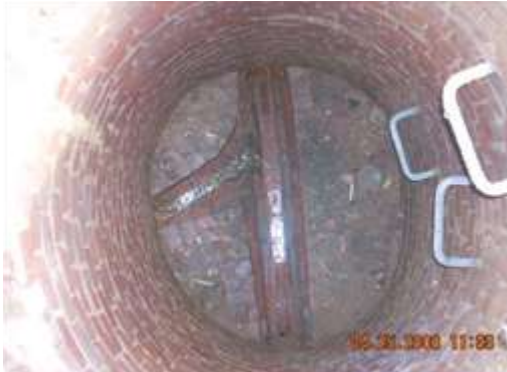
misc

Bench Debris

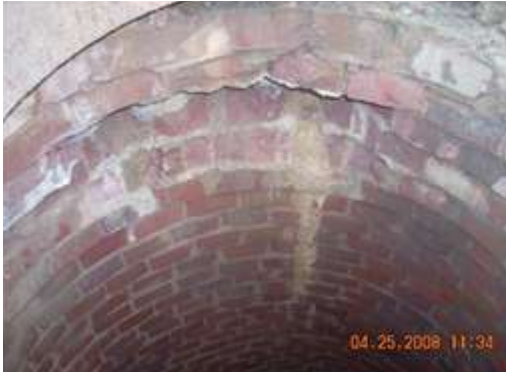
Defect 2

Condition: ☐ Sound ☐ Cracked ☐ Root Intrusion ☐ Loose Brick ☒ **Deteriorated**

deteriorated corbel bricks

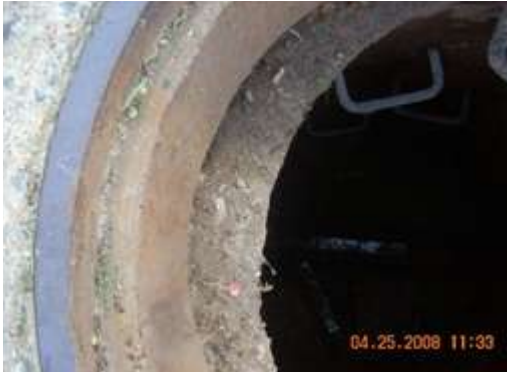
Defect 1

Frame Offset: **2** (in.) Condition: ☒ Sound ☐ Cracked ☐ Leaks

frame offset

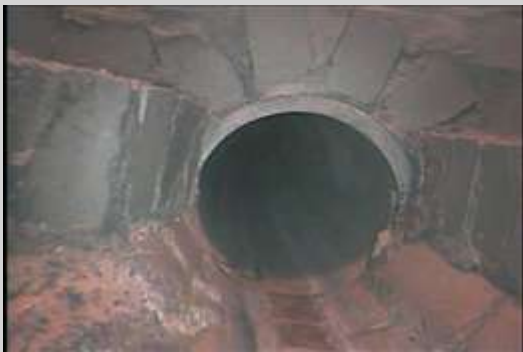
12 O'Clock Outflow

8 in. Circular Gravity Sewer
Pipe Out @ 12 O'Clock

Pipe Height: **8.4** (in.) Rod and Bar (Angled)
Pipe Material: **Clay** ☐ Pipe Lined
Invert Depth: **8.20** (ft.) Flow Characteristics: **Slow**
Deposits: ☒ None ☐ Mud ☐ Sludge ☐ Debris ☐ Grease
Silt Depth: **0** (in.) Deposits Extent:
Infiltration: **None** Pipe Seal Cond: **Sound**

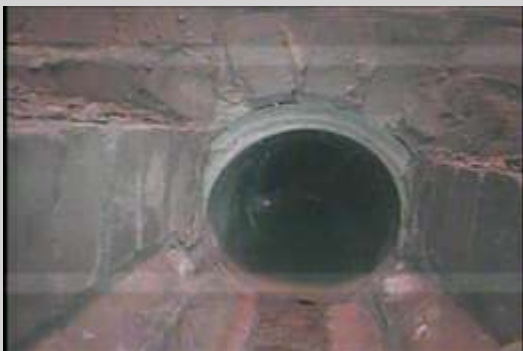
6 O'Clock Inflow

8 in. Circular Gravity Sewer
Pipe In @ 6 O'Clock

Pipe Height: **8.4** (in.) Rod and Bar (Angled)
Pipe Material: **Clay** ☐ Pipe Lined
Invert Depth: **7.98** (ft.) Flow Characteristics: **Slow**
Deposits: ☒ None ☐ Mud ☐ Sludge ☐ Debris ☐ Grease
Silt Depth: **0** (in.) Deposits Extent:
Infiltration: **None** Pipe Seal Cond: **Sound**

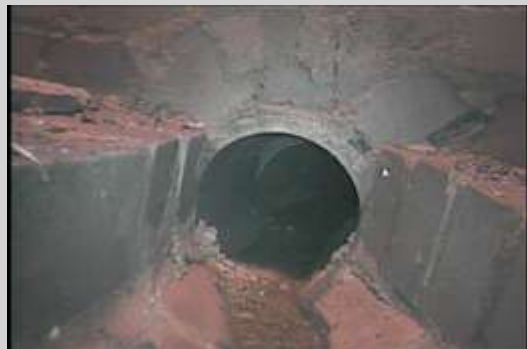
9 O'Clock Inflow

6 in. Circular Gravity Sewer
Pipe In @ 9 O'Clock

Pipe Height: **6** (in.) Rod and Bar (Angled)

Pipe Seal Cond: **Sound**
